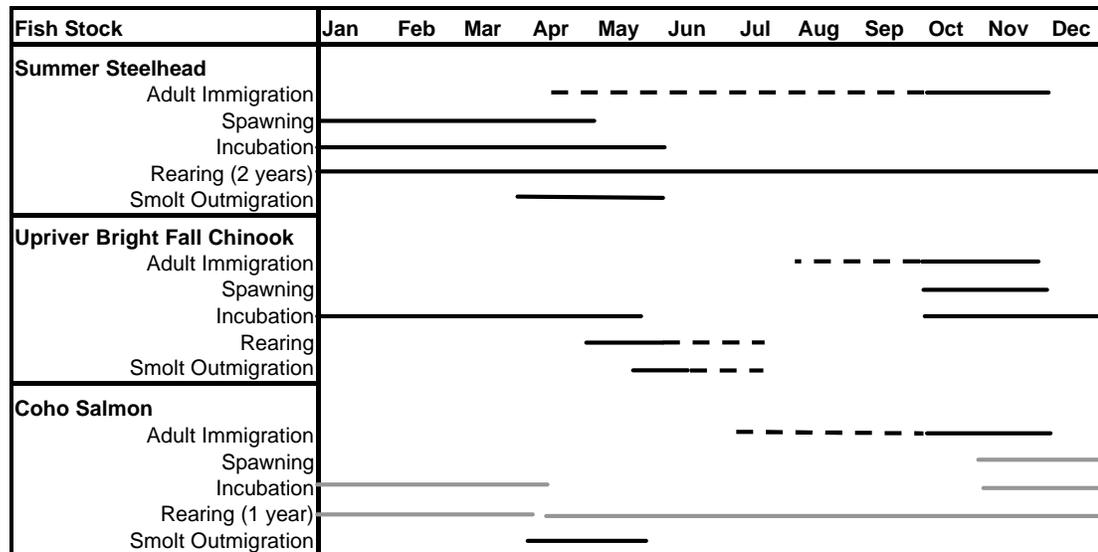
Figure 5-2. Depiction of the Timing of Key Life History Phases of Anadromous Fish Species Found in WRIA 31 (adapted from Berg et al. 2001; Lautz 2000). Solid black lines indicate life history stages found in WRIA 31. Dashed black lines indicate life history stages that may be found in Columbia River backwaters near the mouth of creeks, but are not likely occurring further upstream. Solid gray line indicates life stages that are not known to occur in the basin.

Adults enter the Columbia from May to November and hold in the Columbia until fall and winter rains allow them to enter subbasin streams. The adults will hold in Rock Creek and its tributaries until they spawn in February through April (Berg et al. 2001; Figure 5-2).

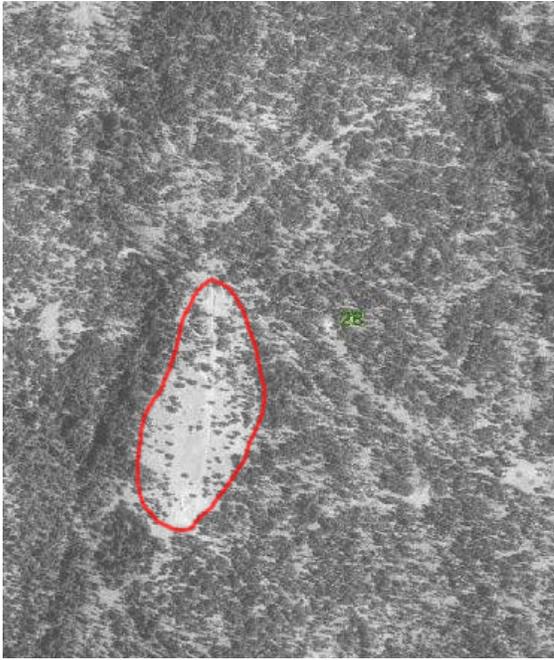
Figure 5-3. Aerial Photograph of Typical Forest within the Managed Timber Lands of the Rock Creek Basin. The area in red is naturally sparse.

Timber harvest in the headwater area is largely conducted through partial cuts. This approach to forest management leaves a somewhat sparse forest on the landscape (Figure 5-3). Historically, this area would have experienced high frequency, low intensity fires (Agee 1993). Fire return intervals were likely similar to those documented in the Warm Spring area. There, fire is estimated to have returned every 11 to 16 years (Weaver 1959).

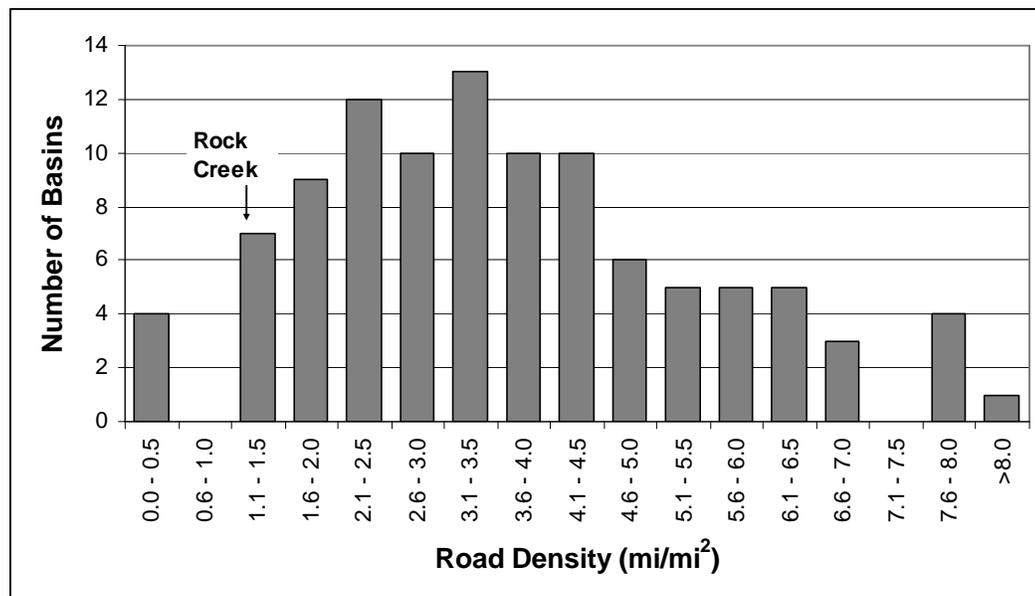
Figure 5-4. Road Density in Basins on the Eastside of Washington State. Data compiled from watershed analyses completed under the Washington Department of Natural Resources' Watershed Analysis Methodology. The road density in Rock Creek basin is 1.5 miles per square mile.

The magnitude of effect of roads has been highly variable in studies conducted across the western United States. Effects have ranged from no effect to an increase in peak flows of up to 12 percent. The larger effects were found in smaller basins where both stream density and road density were high. Peak flows were found to increase significantly when road density exceeded 12 miles of road per square mile (Harr et al., 1975), which is substantially higher than the density found in Rock Creek. In general, the relative affect of roads decreases as the magnitude of the storm event increases. Hence, roads are more likely to affect average flows than the major peak events (Coe 2004). Given the magnitude of effects found in other studies, the low road density in the Rock Creek subbasin, and the configuration of the road system, significant effects on hydrology due to roads is unlikely in this subbasin.

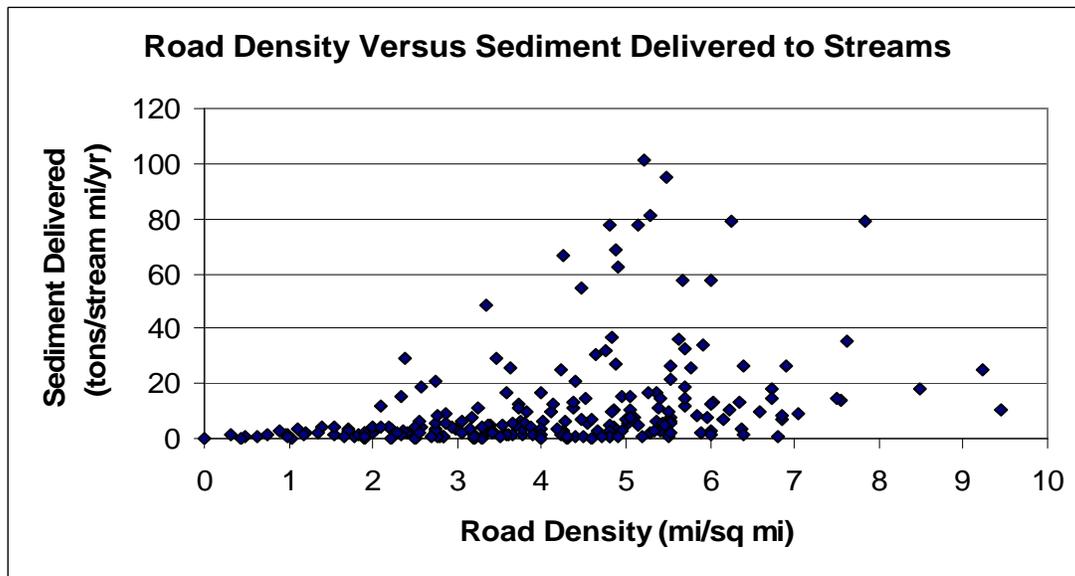
Figure 5-5. Sediment Delivered to Streams as a Function of Road Density. Based on sediment loads estimated using the WDNR watershed analysis methodology (Glass 1999).

Sediment Inputs. Sediment delivered to streams from road systems is a function of the connectivity of the road system to the stream network, the surfacing of the roads, the configuration of the roads, road gradient, and traffic levels (Bilby et al. 1989; Megahan 1974; Megahan and Ketcheson 1996; Reid and Dunne 1984; Sullivan and Duncan 1980; Swift 1984; Vincent 1985). Road density is indirectly related to sediment inputs in that the potential to have significant affects increases with the number of roads present in a basin (Figure 5-5; Glass 1999). As can be seen in Figure 5-5, the quantity of sediment input from high density road systems can range widely. No cases of high sediment loads arising from low density road systems have been documented. At the road density found

in Rock Creek (1.5 mile per square mile), significant basin-scale inputs are unlikely. However, some roads may be locally affecting habitat through erosion of the road bed.

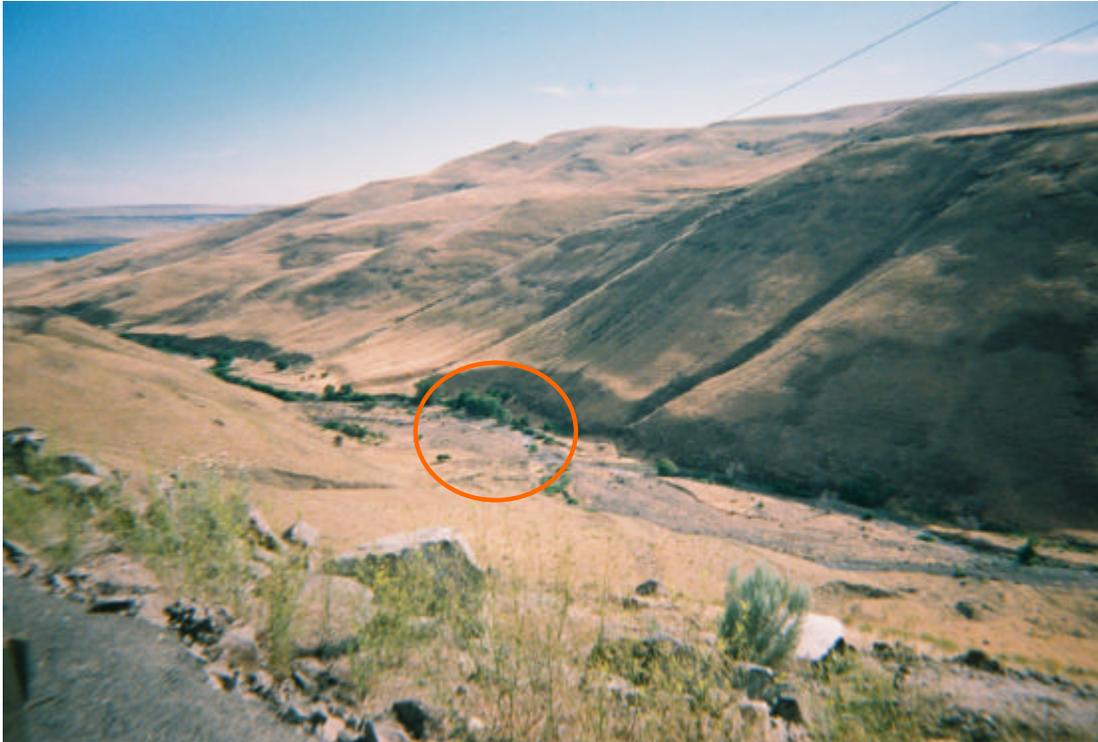
Figure 5-6. Lower Wood Gulch Creek. Note the cluster of trees in the circled area. These grow alongside one of the few pools present in late June 2004.

In late June 2004, the channel was dry with the exception of a few pools. Three pools were observed in the lower 5 miles of the creek. Riparian vegetation is sparse and is most developed in the areas near pools (Figure 5-6). The lowest reach running through Sundale passes near a horse pasture. A hole dug in the ground indicated that water was available roughly 18 inches below the surface, suggesting some subsurface flow of water.
